DECATUR FARM LONG-TERM CAPITAL RESERVE STUDY

DECATUR FARM HOA
BERLIN, MARYLAND

JANUARY 2020
GMB FILE NO. R190199

LONG-TERM CAPITAL RESERVE STUDY

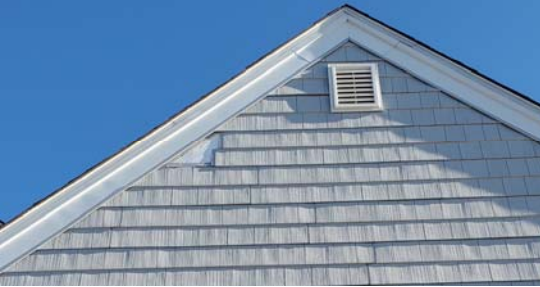
1: Vinyl Siding

The vinyl siding appeared to be in fair condition at the time of our site visit. There were some areas observed where the siding had come loose or blown off and we recommend these areas be addressed soon to ensure the building is protected. With proper maintenance, we expect the vinyl siding to last for its full life expectancy of 40 years.

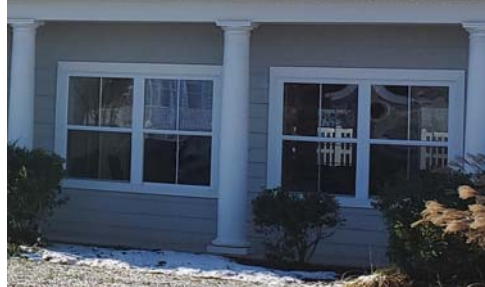
2: Windows (double window = 2)

The windows appeared to be in good condition. We did not observe any signs of leakage at the time of our site visit. We expect the windows to last for their full life expectancy of 30 years.

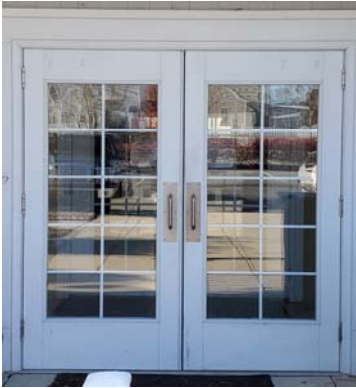
3: Exterior Doors (double door = 2)

The double doors appeared to be in good/fair condition. There were some signs of sagging and the opening mechanisms were not operating smoothly. These issues can be corrected with maintenance and therefore we have not reduced the life expectancy of this item. We expect the doors to reach their full life expectancy of 30 years. The prices shown for the doors, windows and siding is intended to cover removal of the existing items and installation of the new ones.

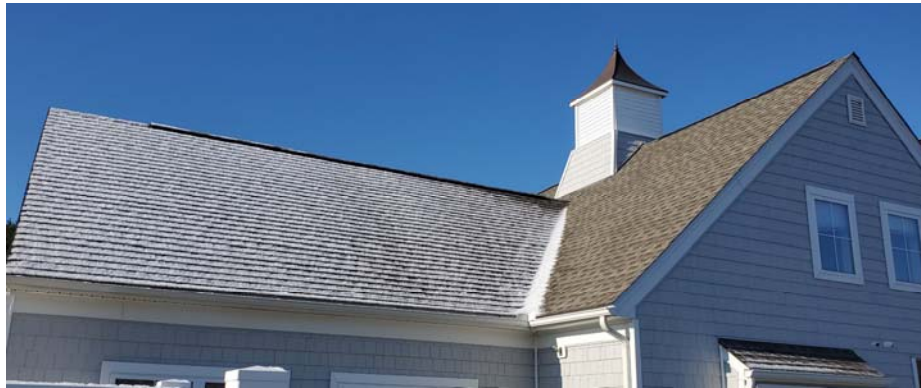
4: Asphalt Shingle Roof

The asphalt shingles appeared to be in good condition at the time of our site visit. We did not observe any signs of leakage or loose/damaged shingles. We expect the asphalt shingles to reach their full life expectancy of 30 years. The price shown for the shingles is intended to cover an overlay of shingles since it is believed there is currently only one layer of shingles in place. If removal of the shingles is desired, the price will increase slightly.

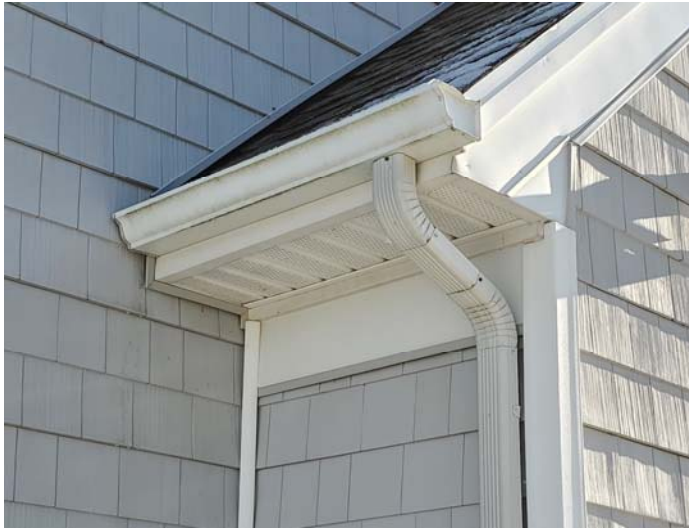
6: Gutter & Downspout

The vinyl soffit around the perimeter of the building appeared to be in good condition. The aluminum gutters and downspouts also appeared to be in overall good condition. The exterior lighting appeared to be in good condition with a single dislodged fixture observed. The vinyl fencing around the pool and the outdoor concrete slab appeared to be in good condition as well. With proper maintenance, we would expect all of these items to reach their full life expectancy of 30 years. The cost shown for these items is intended to cover removal and replacement with new items.

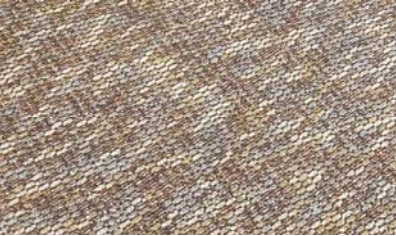
8: Carpet

We observed the carpet, tile and vinyl flooring throughout the building and did not see any significant signs of wear. The flooring in the gym was covered with a rubber matting. We have added this line item to the report and extended the life expectancy of the painted concrete since it is now protected. The pricing shown for the carpet, tile and vinyl flooring is intended to cover removal and replacement.

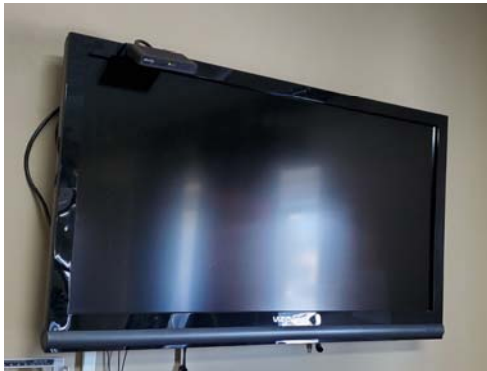
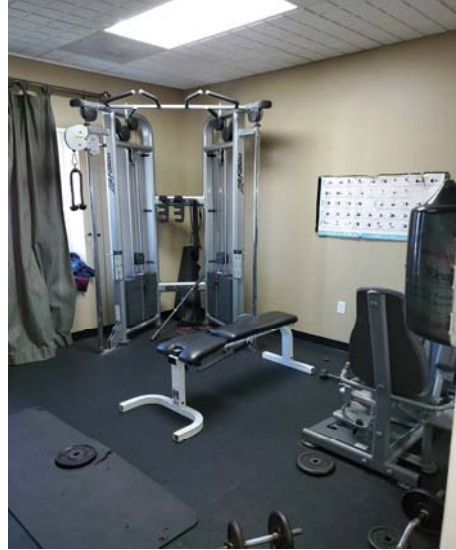
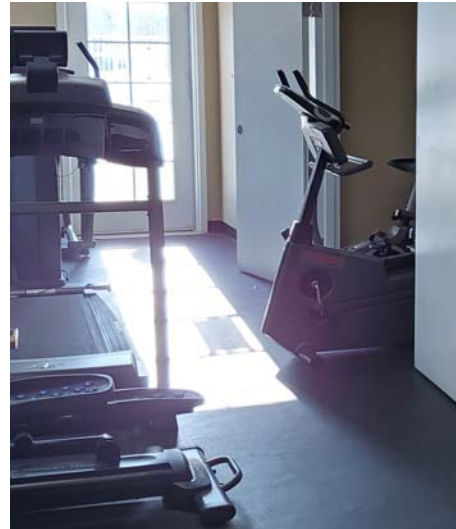
The gym was in use during our site visit. Overall the equipment was in good/fair condition. The costs for these items is intended to cover replacement and are based on cost data provided by the property manager. We understand that the gym equipment is replaced on an as needed basis and the average life expectancy shown is for budgetary purposes.

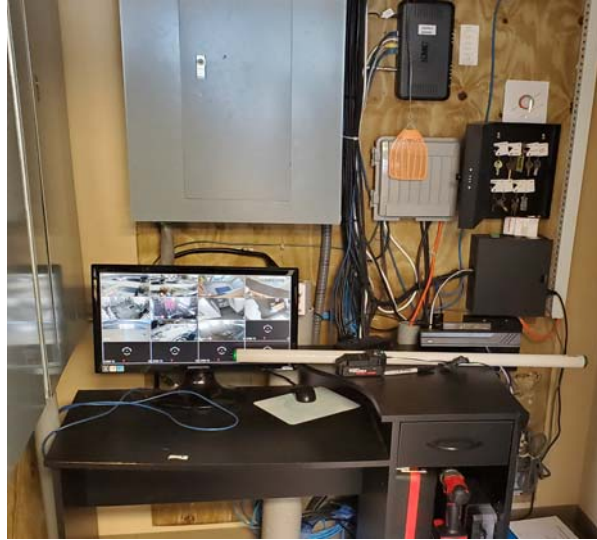
21: Security Cameras

The security cameras appeared to be functioning properly and in good condition at the time of our site visit. The security system was replaced in 2015 and we expect it to need replacement after 15 years.

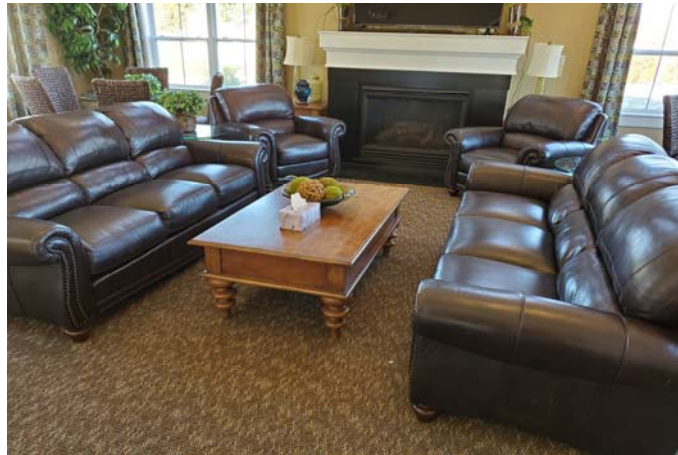
23: Gas Fireplace

The gas fireplace and furniture appeared to be in good condition at the time of our site visit. The fire place was not in use but we have not been told of any concerns. We would expect both of these items to reach their full life expectancies.

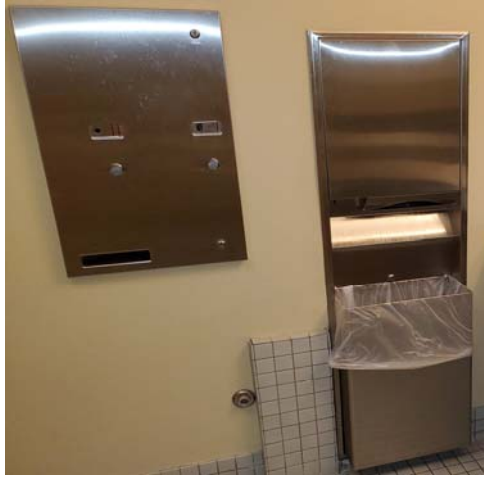
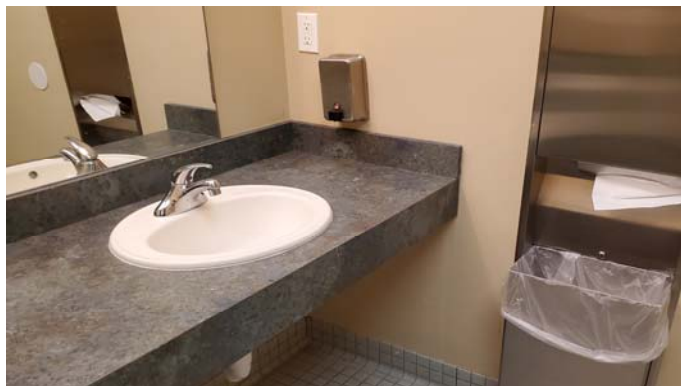
The bathrooms and showers appeared to be in good/fair condition at the time of our site visit. We would expect all of these components to reach their full life expectancies. The costs associated with these items is intended to cover removal and replacement of the existing items.

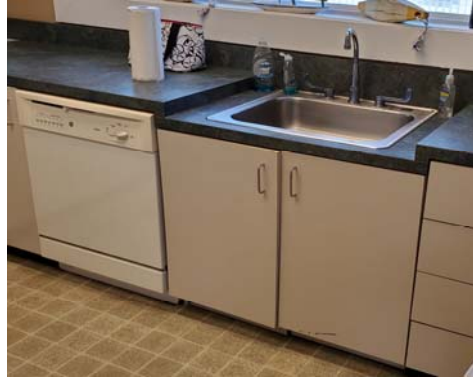
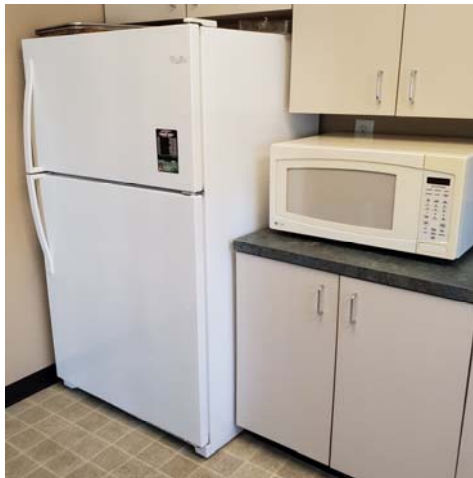
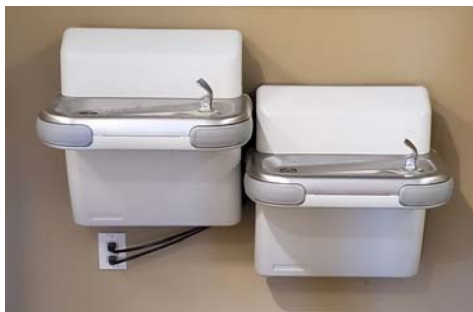
The kitchen appliances appeared to be in overall fair condition. We did not test any of the appliances but have not been told of any current problems. Life expectancy for these items has been taken from the previous LTR report and these items are intended to be replaced as needed.

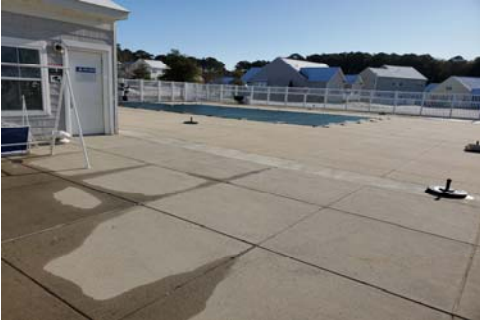
35: Concrete Slab

The pool area was locked during our site visit but we were able to see most of the concrete slab and did not see any concerns from outside of the fence. We have extended the pool slab life expectancy to 50 years in total. The cost associated with this item is intended to cover removal and replacement of the concrete slab.

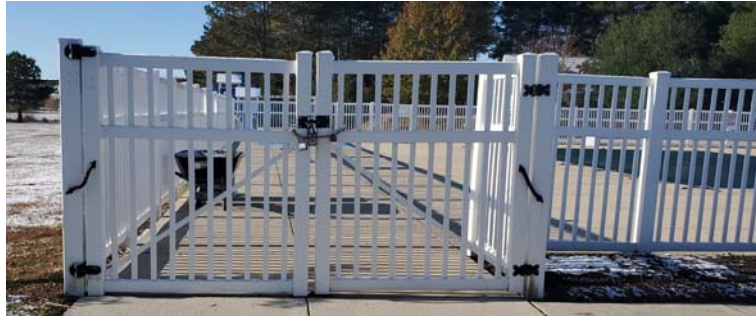
38: Vinyl Fence

The vinyl fencing appeared to be in good condition. We would expect this item to meet its full life expectancy of 30 years. The cost associated with this item is intended to cover removal and replacement of the existing fence. The pool furniture has been added to this report. We were unable to observe the furniture at the time of our visit however we have estimated that the furniture will require replacement every 15 years.

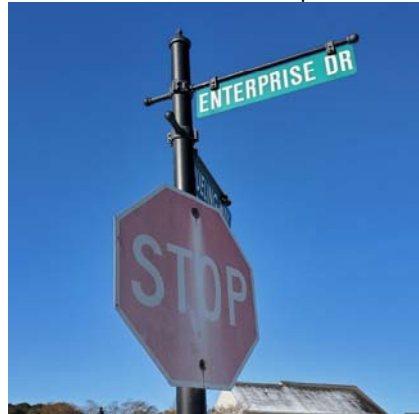
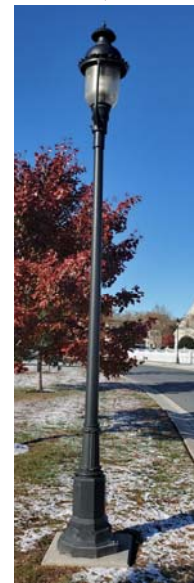
42: Exterior Street Lamps

The street lamps appeared to be in fair to good condition at the time of our site visit. The street signs and posts appeared to be in good to fair condition, however some of the signs were showing signs of fading and should be replaced. We have added a new line item for signage replacement which is separated from the posts and street signs.

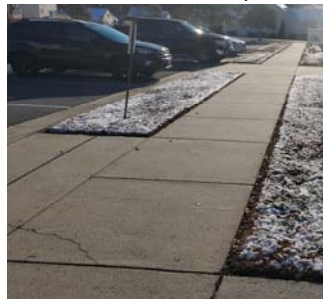
46: Sidewalk

The sidewalks had some signs of cracking but overall appeared to be in good/fair condition. We would expect the sidewalks to reach their full life expectancy.

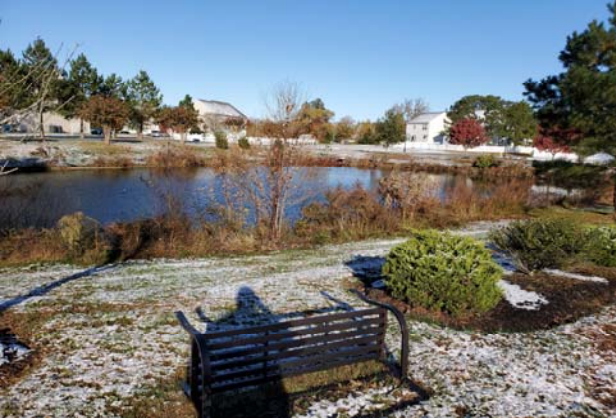
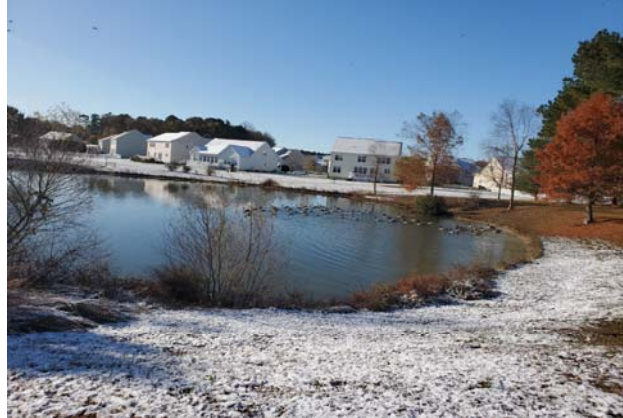
47: Dredging

The ponds were showing signs of soil accumulation along the edges but did not appear to be building up around the outfall structures. Typically we would recommend ponds to be dredged and maintained every 20 years.
