DECATUR FARM LONG-TERM CAPITAL RESERVE STUDY

DECATUR FARM HOA
BERLIN, MARYLAND

JANUARY 2020
GMB FILE NO. R190199

LONG-TERM CAPITAL RESERVE STUDY

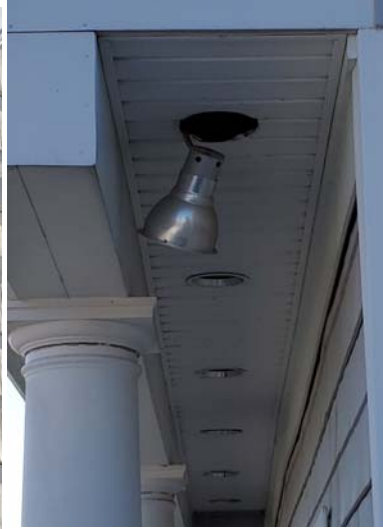
7: Exterior Lighting

The vinyl soffit around the perimeter of the building appeared to be in good condition. The aluminum gutters and downspouts also appeared to be in overall good condition. The exterior lighting appeared to be in good condition with a single dislodged fixture observed. The vinyl fencing around the pool and the outdoor concrete slab appeared to be in good condition as well. With proper maintenance, we would expect all of these items to reach their full life expectancy of 30 years. The cost shown for these items is intended to cover removal and replacement with new items.

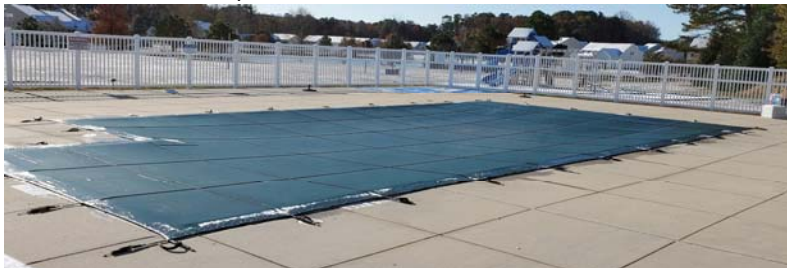
40: Interactive Fountains

The pool area was locked during our site visit but we were able to see most of the concrete slab and did not see any concerns from outside of the fence. We have extended the pool slab life expectancy to 50 years in total. The cost associated with this item is intended to cover removal and replacement of the concrete slab.
